Manhole Inspection Summary

Manhole # S19CC1020MH

Insp Date: **6/28/07 11:05 AM**

Location Address: **DRUID PARK DR**

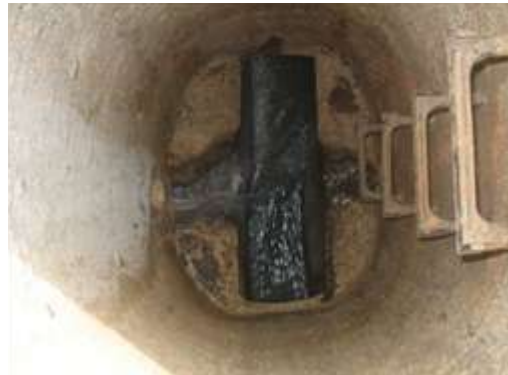
Top View

Bench debris.

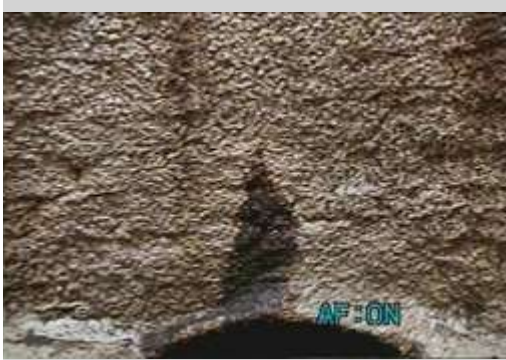
Defect

Infiltration: ☐ None ☐ Joint ☐ Cracks ☐ Mortar ☐ Roots ☒ **Wall**

Barrel infiltration.

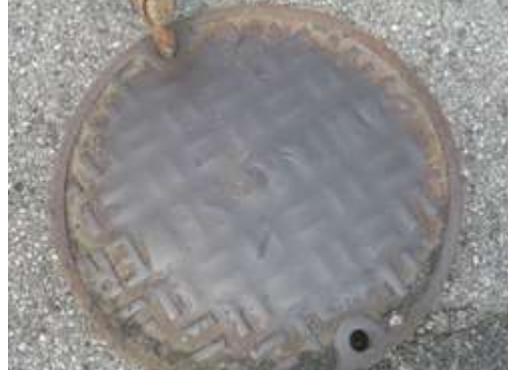
Defect

Condition: **Worn**

Worn cover.

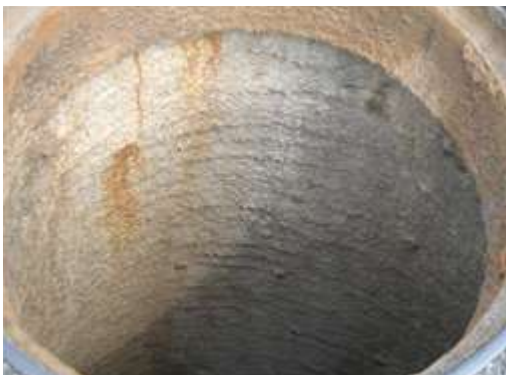
Defect

☒ **Leaks**

Infiltration: ☐ None ☒ **Joint** ☐ Cracks ☐ Mortar ☐ Roots ☒ **Wall**

Frame leaks. Adjustment infiltration.

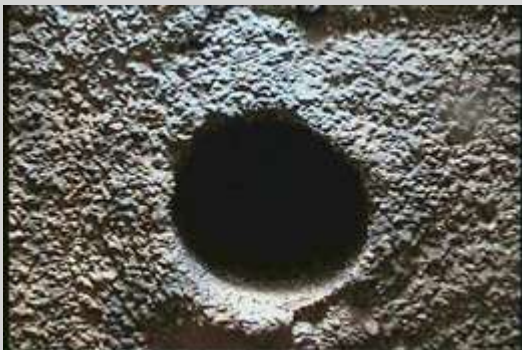
8 in. Circular Gravity Sewer

Infiltration: **Evidence** Pipe Seal Cond: **Unknown**
